## Customer Complaint Analysis Report

Product Type : MLCC

Part No. : 0805X475K250CT

File No. : DQM-100208

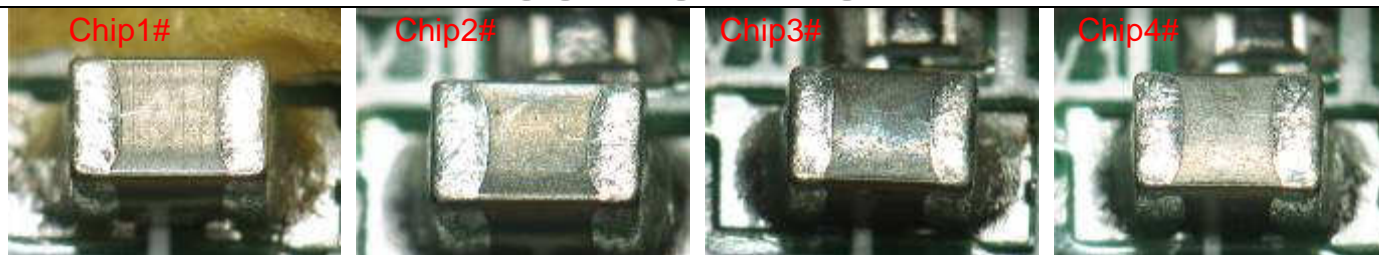
1. 外觀檢查（於 PCB 板上），結果顯示 Chip 外觀正常，如 Fig 1~ Fig4 所示：

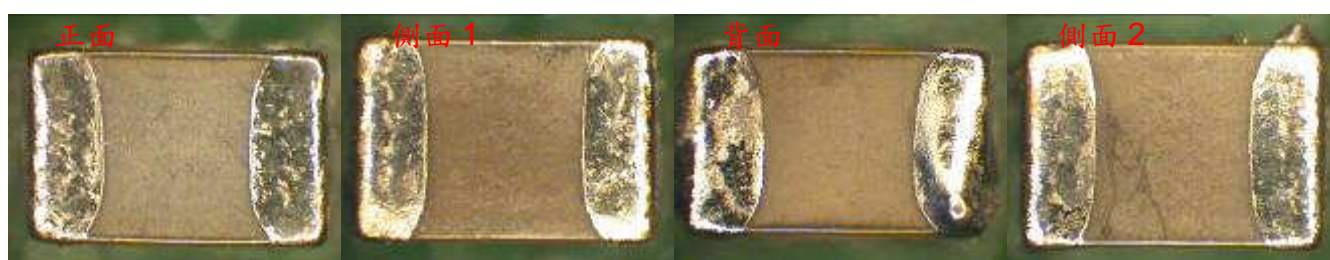
Fig 5 (Chip1#)

2. 外觀檢查（為避免傷害 Chip，用熱風槍將 Chip 取下），結果顯示 Chip1#、Chip2#外觀正常，Chip3#、Chip4#本體疑似有 Thermal Crack 現象，如 Fig 5~ Fig8 所示：

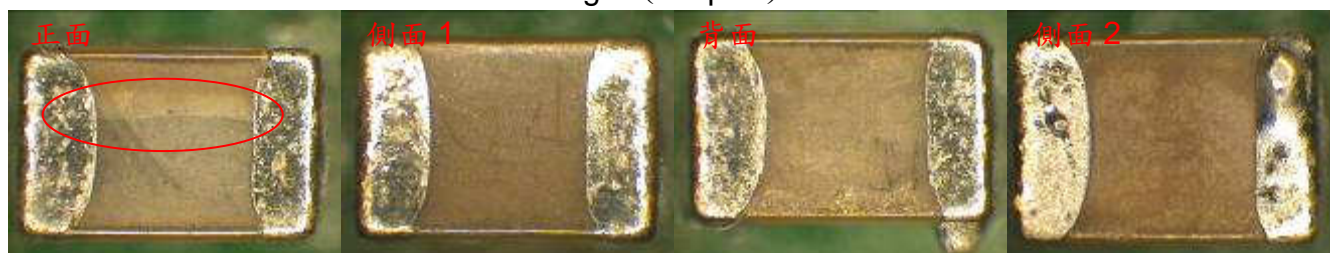
Fig 7 (Chip3#)

外觀檢查結果顯示 Chip1#、Chip2#外觀正常，Chip3#、Chip4#本體疑似有 Thermal Crack，電性量測結果顯示 Chip 的 Cap、DF、IR 值有超 Spec 現象，DPA 分析顯示 Chip1#~ Chip 4#內部均存在疑似受機械應力造成之 Bending Crack 現象，且 Chip3#、Chip4#內部存在疑似因熱應力造成之 Thermal crack 現象。

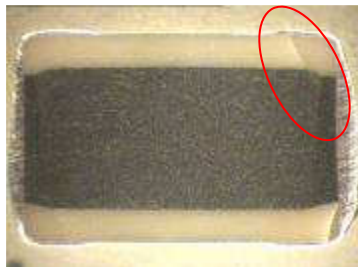
Fig 9 ( Chip1#)

4. DPA 分析，結果顯示 Chip1#~ Chip 4#內部均存在疑似受機械應力造成之 Crack 現象，且 Chip3#、Chip4#內部存在疑似因熱應力造成之 Thermal crack 現象，如 Fig 9~ Fig12 所示：

1. 依據以上分析可知，Chip 內部存在機械應力產生之 Crack 及因熱應力造成之 Thermal crack 是造成產品失效的根本原因。
